**Statement by the School Bus Information Council
Carpenter School Buses
July 1, 2003**

Carpenter School Bus Advisory June 2003

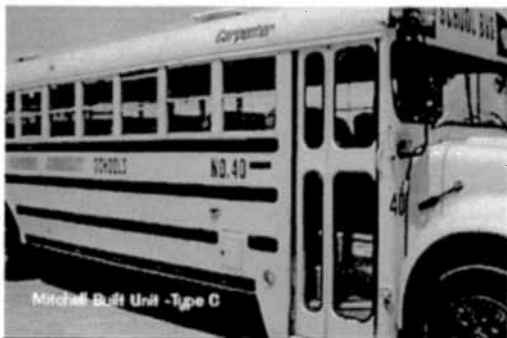
Figure 1: Mitchell built type "C"

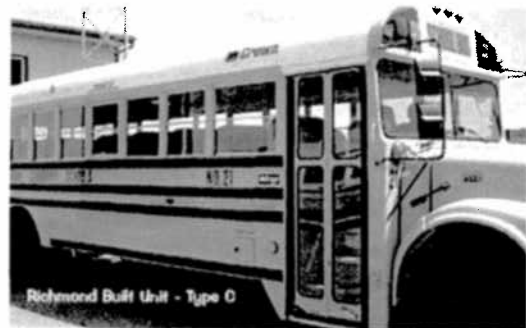
Figure 2: Richmond built type "C"

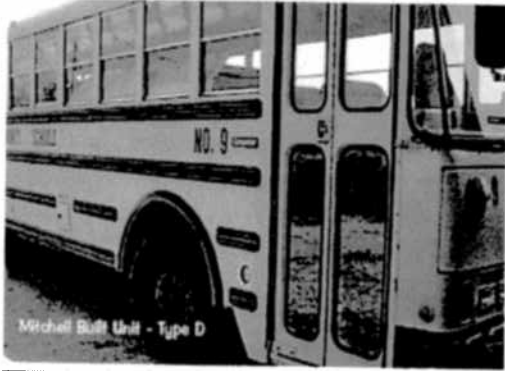
Figure 3: Mitchell built type "D"

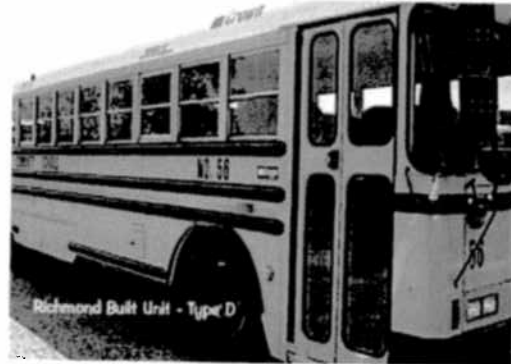
Figure 4: Richmond built type "D"
